# FABRICATION AND INSTALLATION OF PROTOTYPE PROTECTIVE BARRIER SYSTEM

**Final Report**

by
A. J. Palfey
B. A. Russell

THE DOW CHEMICAL COMPANY
FUNCTIONAL PRODUCTS AND SYSTEMS
MIDLAND, MICHIGAN 48640

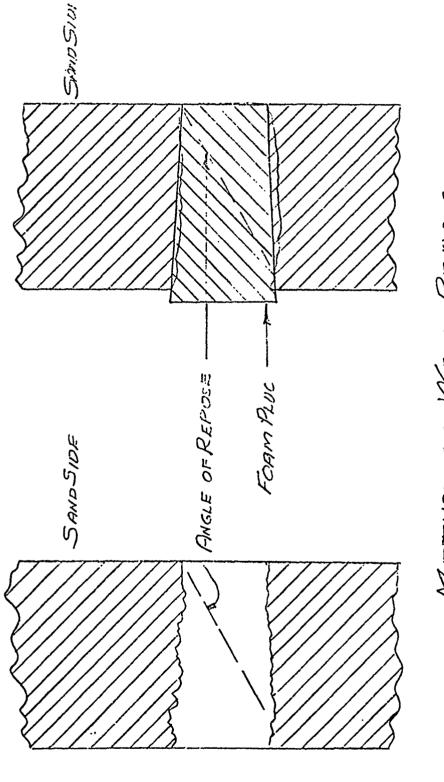
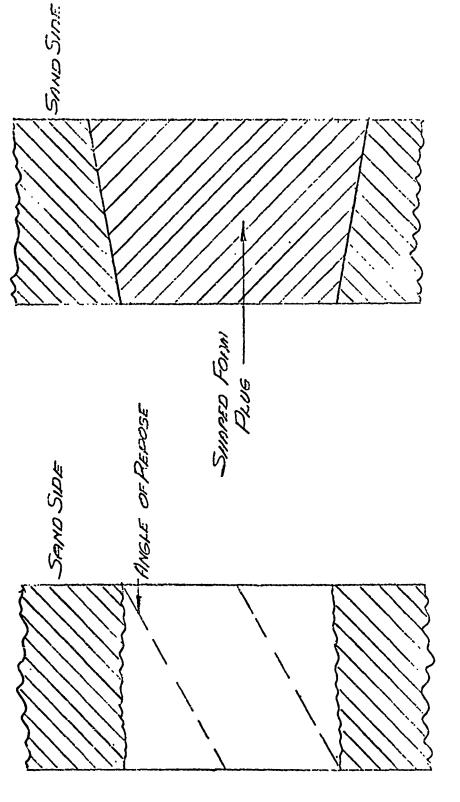
METHOS OF WALL REPORE

METHOD OF WALL REPONDE LARGE HOLE - PLUG

During erection, damage may occur to the walls. Holes in the foam boards may be repaired as shown in the Drawings mentioned above. Broken boards may be replaced from the spare parts that were included with the barrier kit.

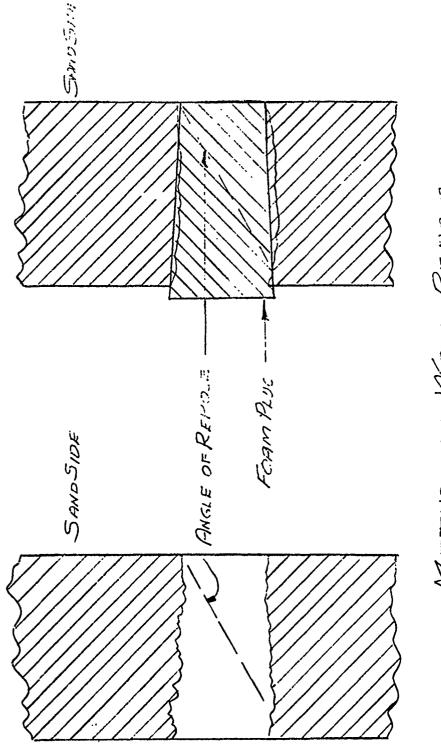
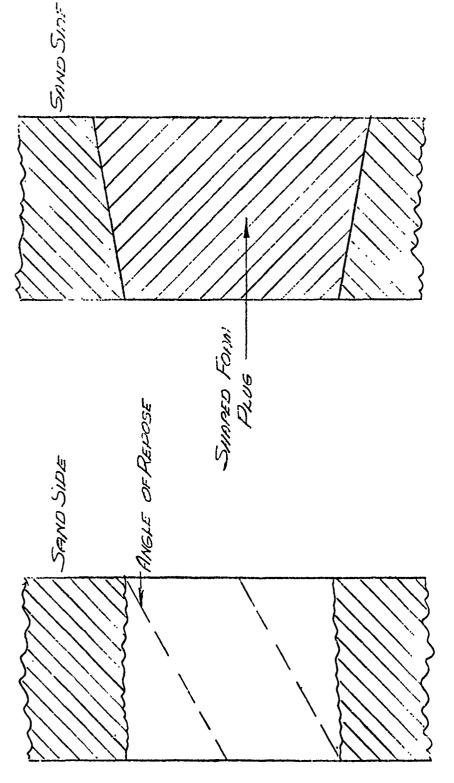
METHOS OF WALL REPAIR
SMALL HOLE WITH HOLE

METHOD OF WALL REPORTED

During erection, damage may occur to the walls. Holes in the foam boards may be repaired as shown in the Drawings mentioned above. Broken boards may be replaced from the spare parts that were included with the barrier kit.
